TIER 2 CONTAMINATED LAND GENERIC QUANTITATIVE RISK ASSESSMENT

LAND SOUTH OF BROADFORD LANE, CHOBHAM, GU24 8EL

REFERENCE: P1057/R1/V2

REPORT PREPARED FOR: SURREY HEATH BOROUGH COUNCIL

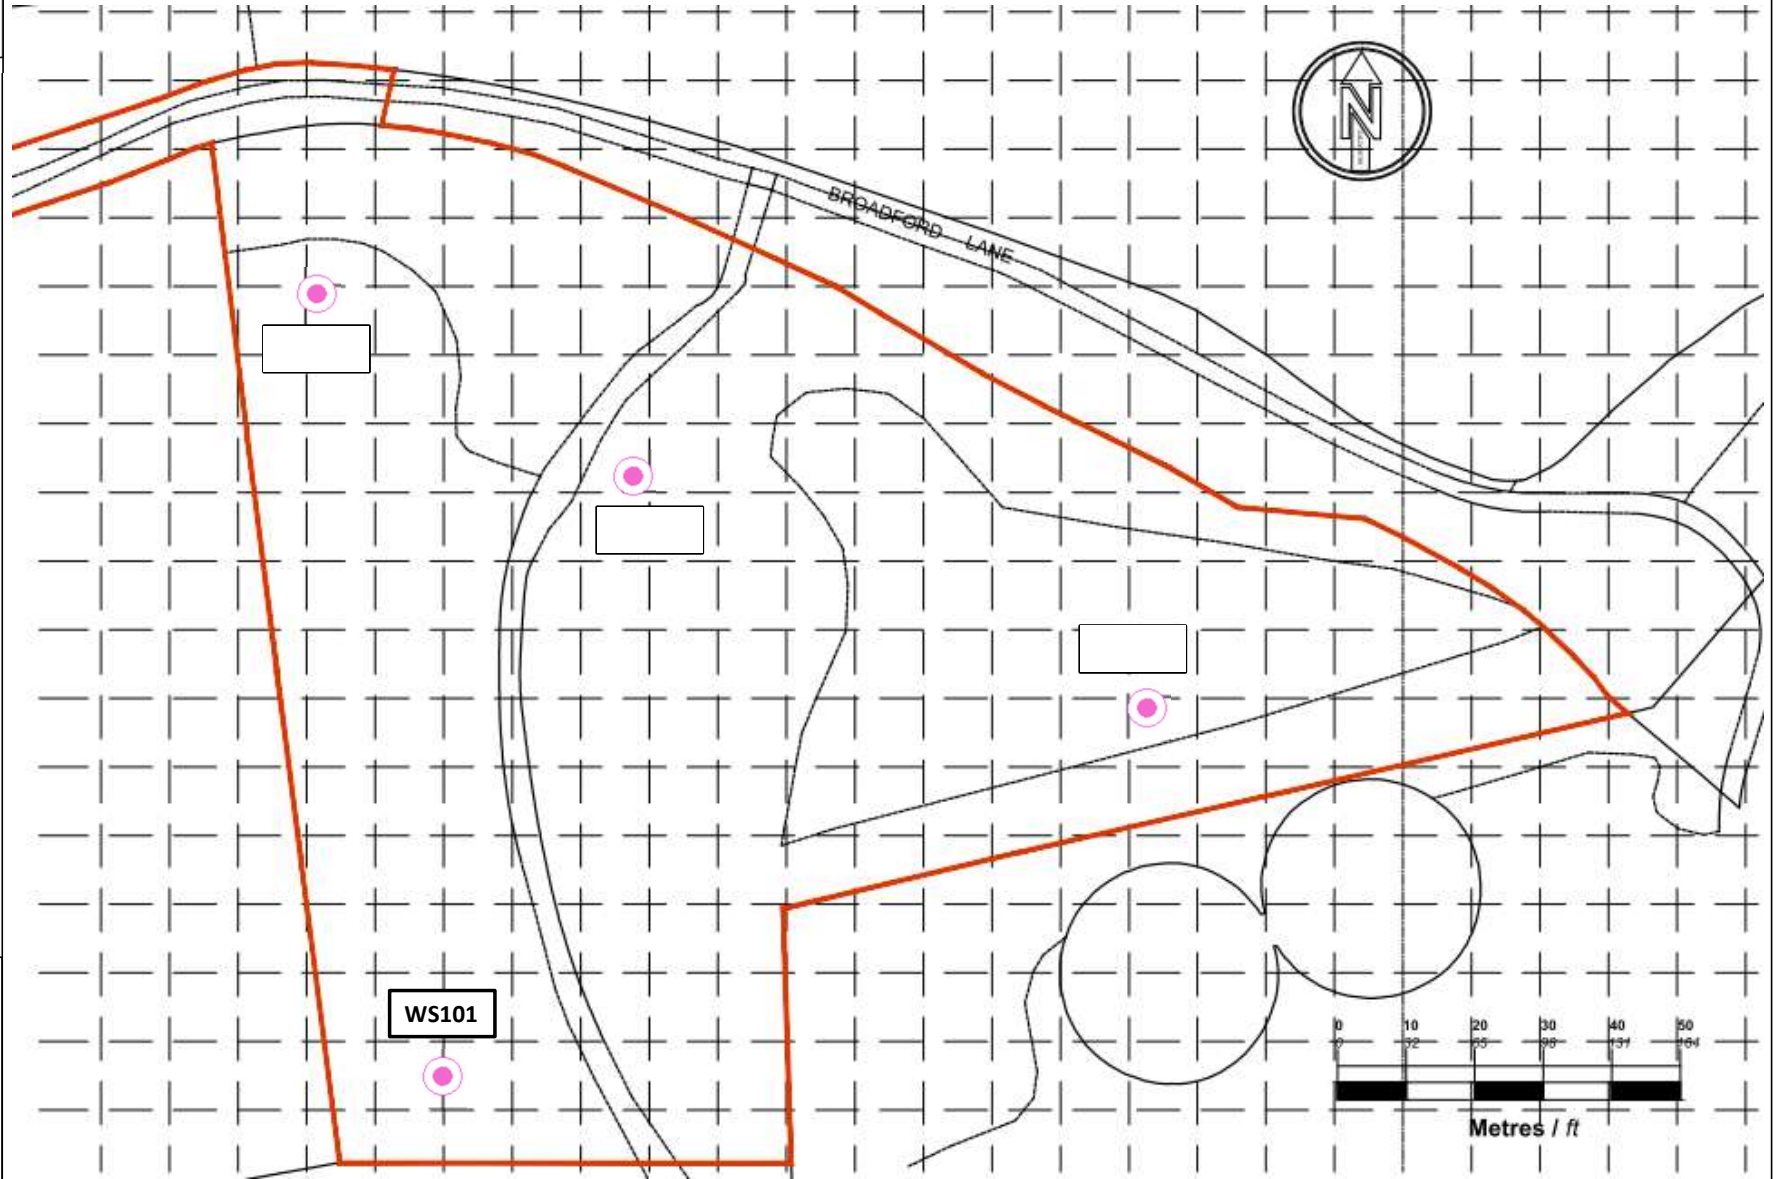
An Exploratory Hole Location Plan is presented as Figure 2 within Appendix I and a selection of photographs is presented within Appendix V.

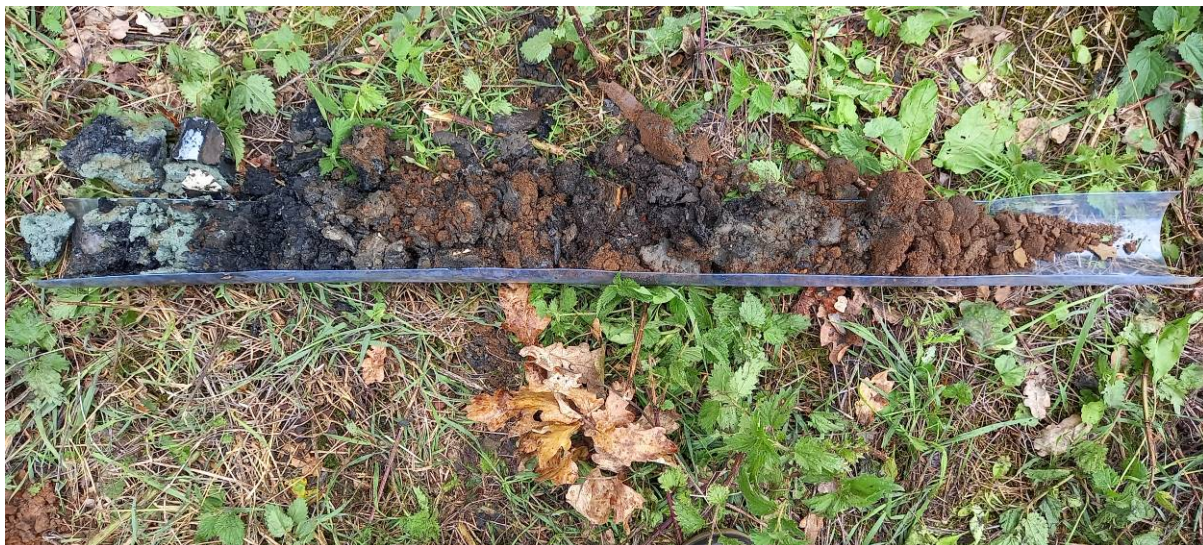
Photograph 9 – WS104 2.0 to 3.0mbgl

Made ground within exploratory hole location WS104, undertaken within the eastern sector of the site, was also encountered at ground level but persisted to depths >3.0mbgl. The soils encountered within this exploratory hole were more typical of landfill type waste comprising brown and black slightly sandy clay with secondary constituents of flint, brick, paper (remnants of a cigarette packet), ceramic, plastic, metal, rubber and fabric. A hydrocarbon and organic odour was encountered at a depth of 1.50mbgl where soils were noted to be stained black.
